SOIL IMPROVEMENT BY PRECOMPRESSION AT A TANK FARM SITE IN CENTRAL JAVA, INDONESIA

Kul Bhushan, President, Group Delta Consultants, Inc., Aliso Viejo, CA, USA
Carlos V. Amante, Project Engineer, Group Delta Consultants, Inc., Aliso Viejo, CA, USA
Ramzi Saaty, Project Manager, Fluor Daniel, Inc., Aliso Viejo, CA, USA

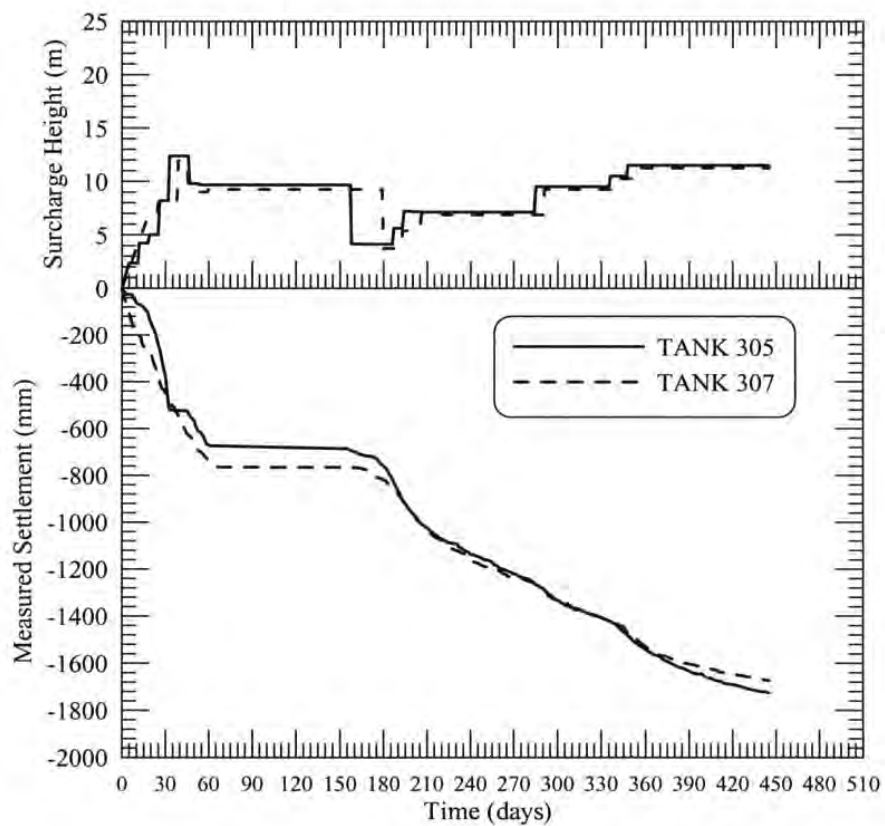
Figure 5. Settlement Data During Surcharge (Tanks 305 and 307)

A summary of measured settlements during surcharge is shown in Table 1. The measured settlements and surcharge heights with time for two tanks are shown in Figure 5. Time settlement data from 15 tanks is shown in Figure 6. The measured total settlement at the center of each tank ranged from 579 to 1726 mm. Prior to surcharge, we made estimates of settlements due to surcharge loads for 90% consolidation which ranged from 840 to 1470 mm.

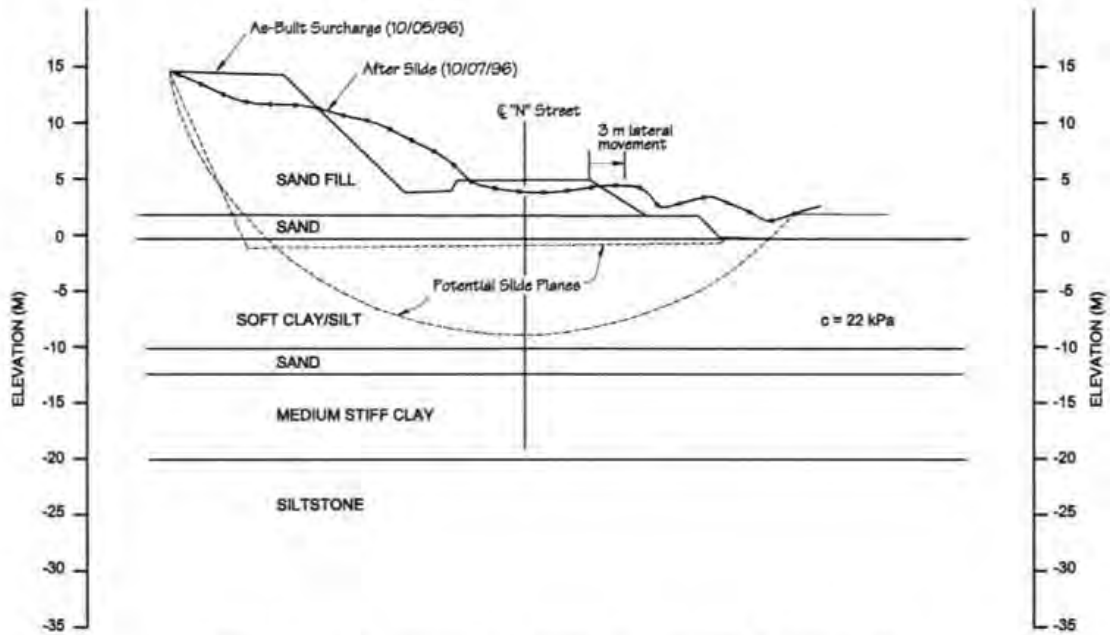
Figure 9. As-built surcharge and after-slide conditions for Tanks 305/307

A slide failure occurred in the surcharge fill at the location of Tanks 305 and 307. The surcharge in the area of these tanks was raised from about El. +2 m to El. +14.88 m during a period of about one month. After a heavy rainfall, the surcharge moved laterally to the north by about 3 m and disrupted the existing ditch located about 50 m to the north of Tank 305. An approximate cross section of the as-built surcharge in the area of Tanks 305 and 307 and the condition after the slide are shown in Figure 9.

Stability analyses of the slide were performed using the computer program STABL/G [5]. We evaluated two types of potential failure surfaces, namely, 1) a deep-seated circular failure through the base of the soft clay, and 2) a sliding block wedge-type failure along a plane near the top of the soft clay/sand interface between El. -0.5 m and El. -1.5 meters.

The analyses under the pre-failure surcharge loading indicated that both a wedge-type failure, and a deep-seated failure through the base of the soft clay, are probable failure mechanisms. Soil shear strengths were back-calculated for both the wedge-type failure and the deep-seated failure conditions. The results indicate that the average shear strength at the surface of the soft clay for the wedge failure was 19 kPa and for the entire clay layer for deep circular failure was 26 kPa. These values are higher than some of the measured or interpreted values of the shear strength of the clay shown in Figure 4.

The factor of safety for the full surcharge height of 14.88 m was calculated to be less than 1.0 for a slide plane along the top of the soft clay layer. The rapid placement of the fill did not provide adequate time for the consolidation of the clay and resulting strength increase. In addition, the presence of the ditch to El. -0.5 m provided a shorter failure path along the top of the soft clay, thus further reducing the factor of safety.

After the slide, various options including use of piles and re-routing of the ditch were considered for remedial measures to support Tanks 305 and 307. The option selected included:

- Removing surcharge in the area and installing new wick drains,
- Resurcharging area of Tanks 305 and 307 in stages,
- Installing inclinometers and additional settlement monuments to measure settlement and lateral ground movement during surcharging,
- Surcharging area of roadway north of Tanks 305 and 307 to increase shear strength,
- Making drainage modifications to prevent ponding of water,

- Developing a monitoring program to assess the settlements, pore pressures, and lateral ground movements, and
- Verifying the shear strength increase by performing cone penetration tests.
