SOIL IMPROVEMENT BY PRECOMPRESSION AT A TANK FARM SITE IN CENTRAL JAVA, INDONESIA

Kul Bhushan, President, Group Delta Consultants, Inc., Aliso Viejo, CA, USA
Carlos V. Amante, Project Engineer, Group Delta Consultants, Inc., Aliso Viejo, CA, USA
Ramzi Saaty, Project Manager, Fluor Daniel, Inc., Aliso Viejo, CA, USA

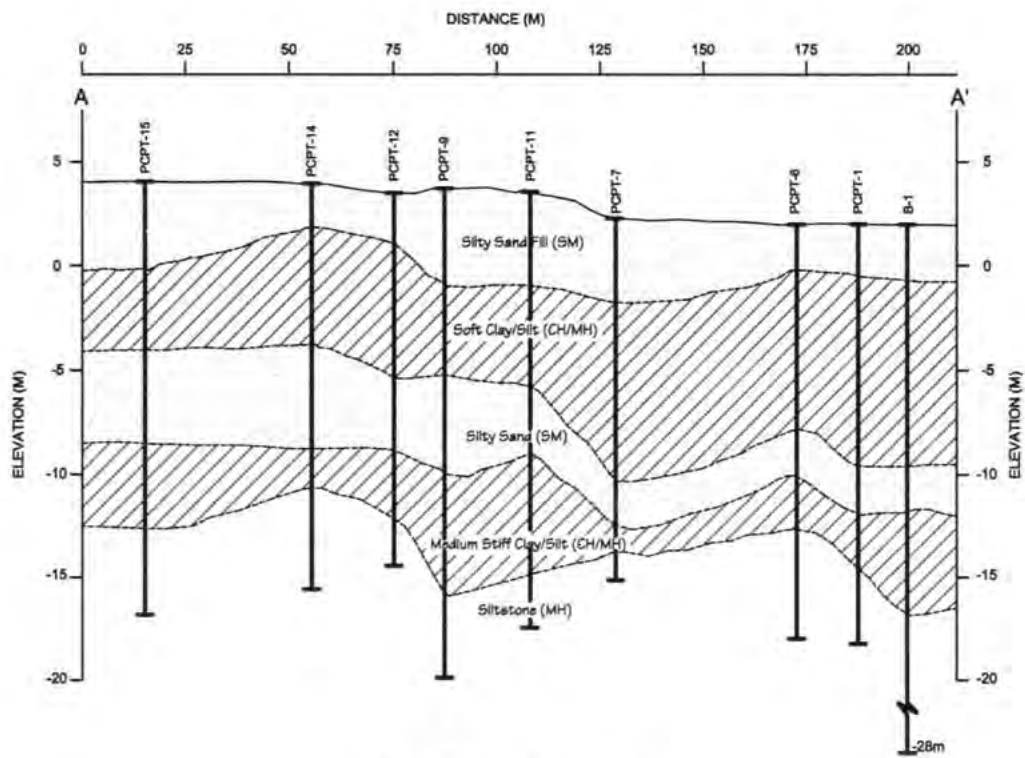
Figure 2. Cross Section A-A'

The subsurface conditions in the tank farm were investigated by performing four rotary wash standard penetration test (SPT) borings with depth ranging from 21.3 to 40.4 m, and sixteen piezocone penetration tests (PCPT) with depths ranging from 13.34 to 29.25 meters. After a slide in the surcharge fill occurred near Tanks 305 and 307, six SPT soil borings and 14 post-surcharge CPTs were performed. A cross section (A-A') through the site is shown in Figure 2.

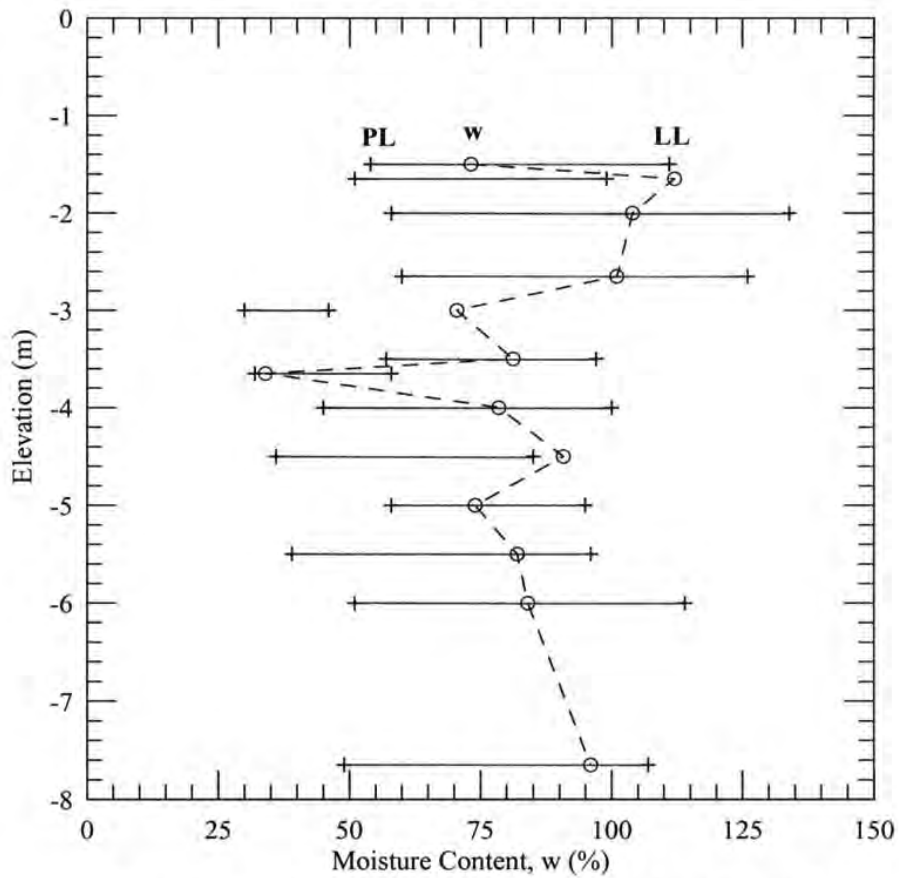
Figure 3. Distribution of Moisture Content (w), Liquid Limit (LL), and Plastic Limit (PL)

The natural moisture content and plasticity data are shown in Figure 3. Undrained shear strengths of disturbed clayey soil samples were measured using hand vane, pocket penetrometer and unconfined compression test. The measured shear strengths of the soft clayey soils ranged from about 4.5 to 25 kN with an average of 15 kN. Undrained shear strength was also estimated by Skempton's 1957 correlation with plasticity index [4], and from CPT tip resistance and a cone factor of 15. These results are summarized in Figure 4. The measured S_u values are generally lower than the estimated S_u based on Skempton's formula which is expected because the measured values are obtained from disturbed soil samples. Undrained shear strength from PCPT soundings is in good agreement with shear strengths computed from Skempton's formula.

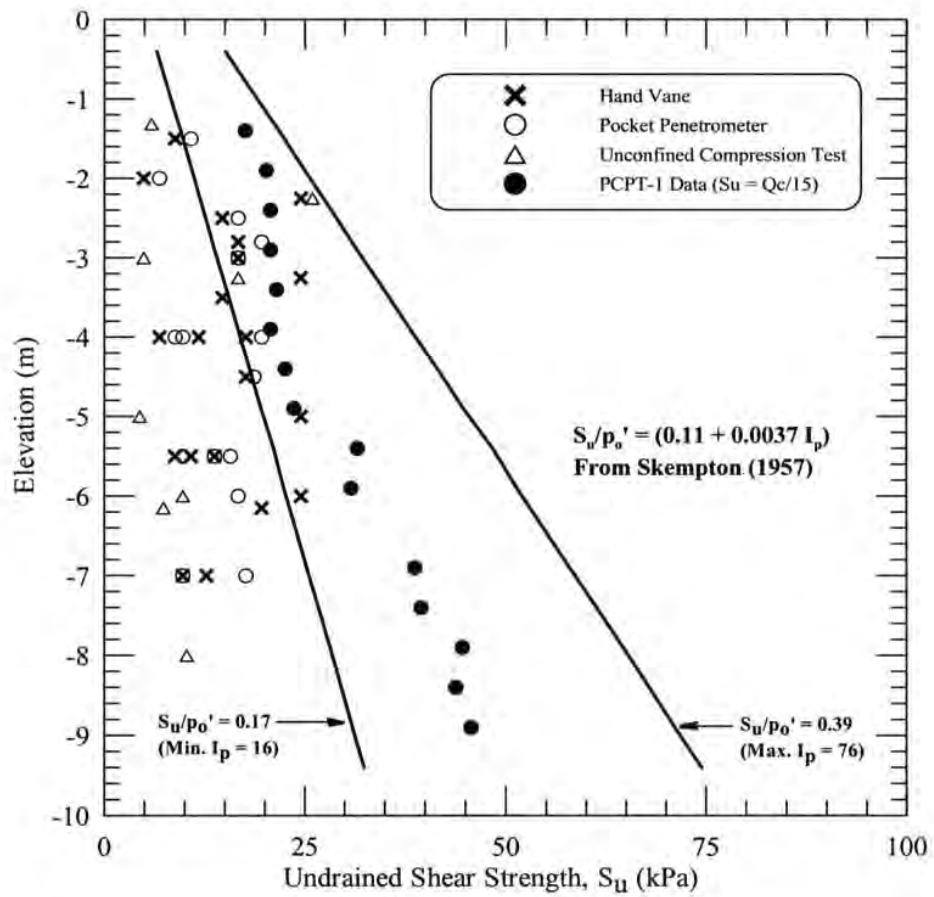
Figure 4. Shear Strength Distribution

The analyses under the pre-failure surcharge loading indicated that both a wedge-type failure, and a deep-seated failure through the base of the soft clay, are probable failure mechanisms. Soil shear strengths were back-calculated for both the wedge-type failure and the deep-seated failure conditions. The results indicate that the average shear strength at the surface of the soft clay for the wedge failure was 19 kPa and for the entire clay layer for deep circular failure was 26 kPa. These values are higher than some of the measured or interpreted values of the shear strength of the clay shown in Figure 4.

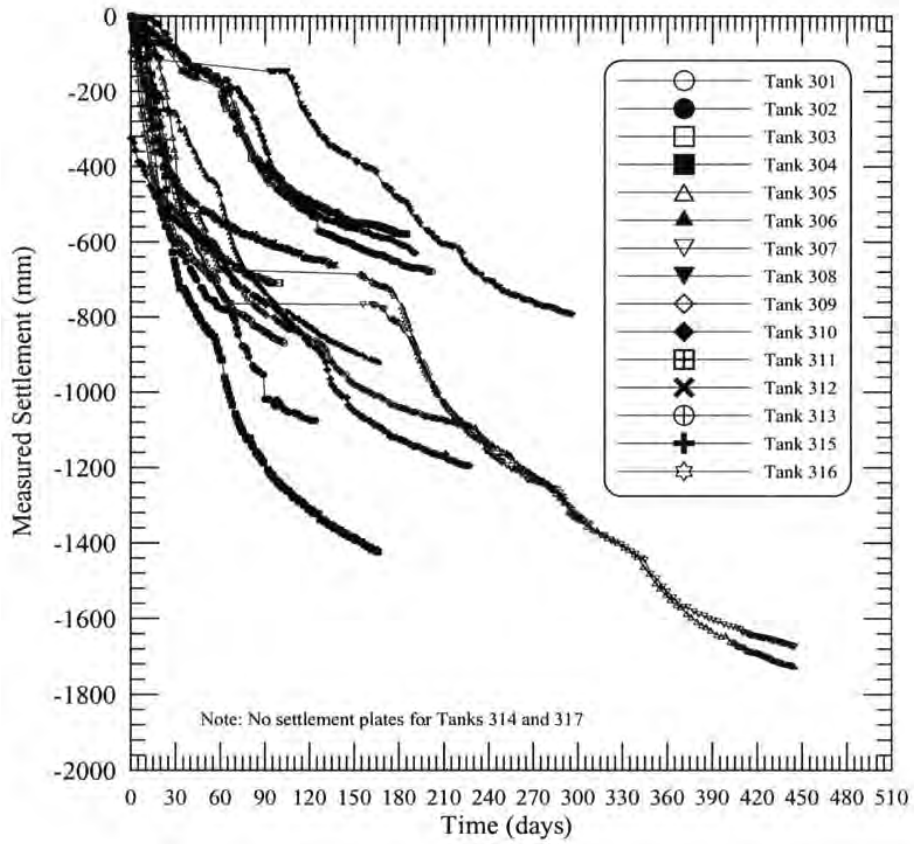
Figure 6. Settlement Data During Surchage

A summary of measured settlements during surcharge is shown in Table 1. The measured settlements and surcharge heights with time for two tanks are shown in Figure 5. Time settlement data from 15 tanks is shown in Figure 6. The measured total settlement at the center of each tank ranged from 579 to 1726 mm. Prior to surcharge, we made estimates of settlements due to surcharge loads for 90% consolidation which ranged from 840 to 1470 mm.

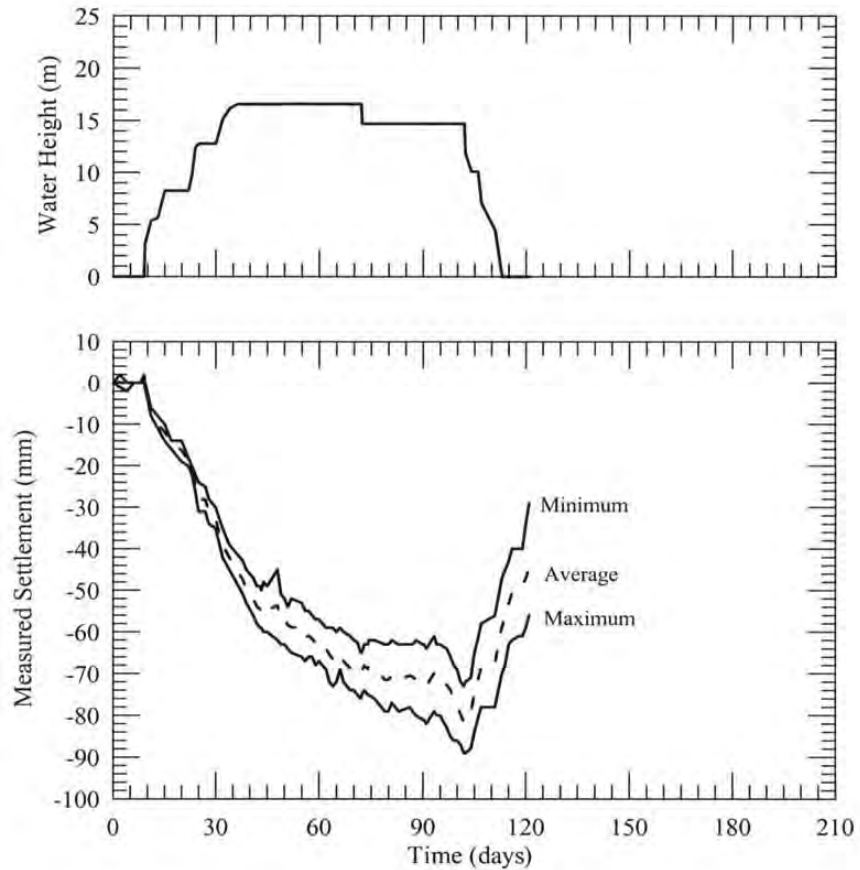
Figure 7. Settlement Data During Water Test (Tank 304)

A summary of observed tank edge settlements during water test is presented in Table 1. Typical observed tank edge settlements and water level variation with time for Tank 304 are shown in Figure 7. Time-settlement data for 15 tanks is shown in Figure 8. The observed minimum and maximum tank edge settlements ranged from 37 to 89 mm.
